•	_	•
	•		
		<b>^</b>	
	Incl (dupe)	().7	
	as	Na Su	mo
٠		DIBUONO	•
		•	
		••	•
	•		
			3/24/80
			777780
	NATIONAL	PROGRAM OF INSPECTION OF NON-FE	DERAL DAMS
		DRAFT REPORT REVIEW COMMENTS	
	130ULT	DAM. IDENTITY NO	MF 00194

# PHASE I INSPECTION REPORT NATIONAL DAM INSPECTION PROGRAM

BOULTER DAM ME 00194

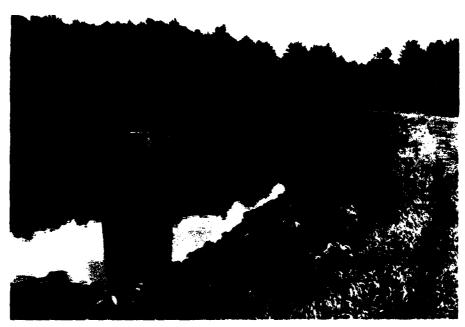
The intake tower is in good condition as shown in Photo No. 11. The operator of the dam was not present at the time of the inspection, and in turn, the service gates were not operated. A steel service bridge spans approximately 44 ft. from the dam crest to the intake tower as shown in Photo No. 12. The trusses are seated on bearings

12. Intake tower and steel service bridge

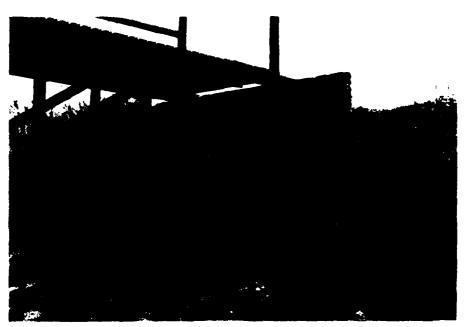
on concrete at both sides. Overall, the bridge is in good condition, though the abutment to the service bridge has moved. This displacement appears to be a downslope translation of the top of the bridge abutment either by a tilting of the abutment pier and footing or structural distress in the abutment pier. This may or may not have been caused by settlement. There is some cracking and spalling at the base of the abutment and some cracking is present at the backwall of the bridge seat, Photo No. 13.

A noticeable bulge occurs in the upstream slope beneath the service bridge. However, it is probable that the embankment was constructed with this configuration. The abutment to the service bridge has moved as described in Section 3.1c. This condition places the structural stability of the service bridge abutment in question.

13. Service bridge abutment

- 6. Repair the cracked and spalled areas of the service bridge abutment; realignment inclusive.
  - 7. Develop a system for monitoring flow out of the internal drainage system such that it may be correlated with reservoir water surface elevation.
